# IONOSPHERIC EXPOSURE FACILITY SPACELABORATORIES HANDBOOK

Science Applications International Corporation

October 1993

Final Report

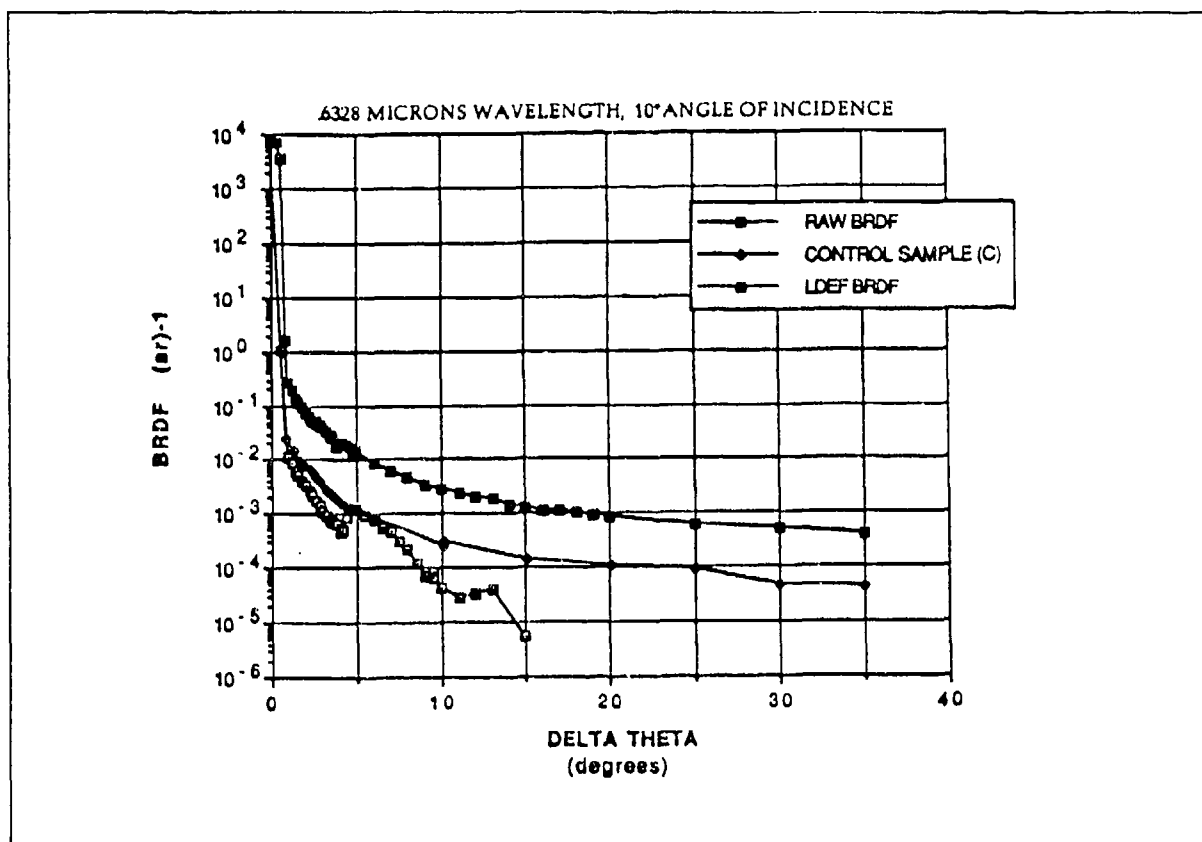
Figure E.28. BRDF Measurement for Silver-Coated Fused ULE™

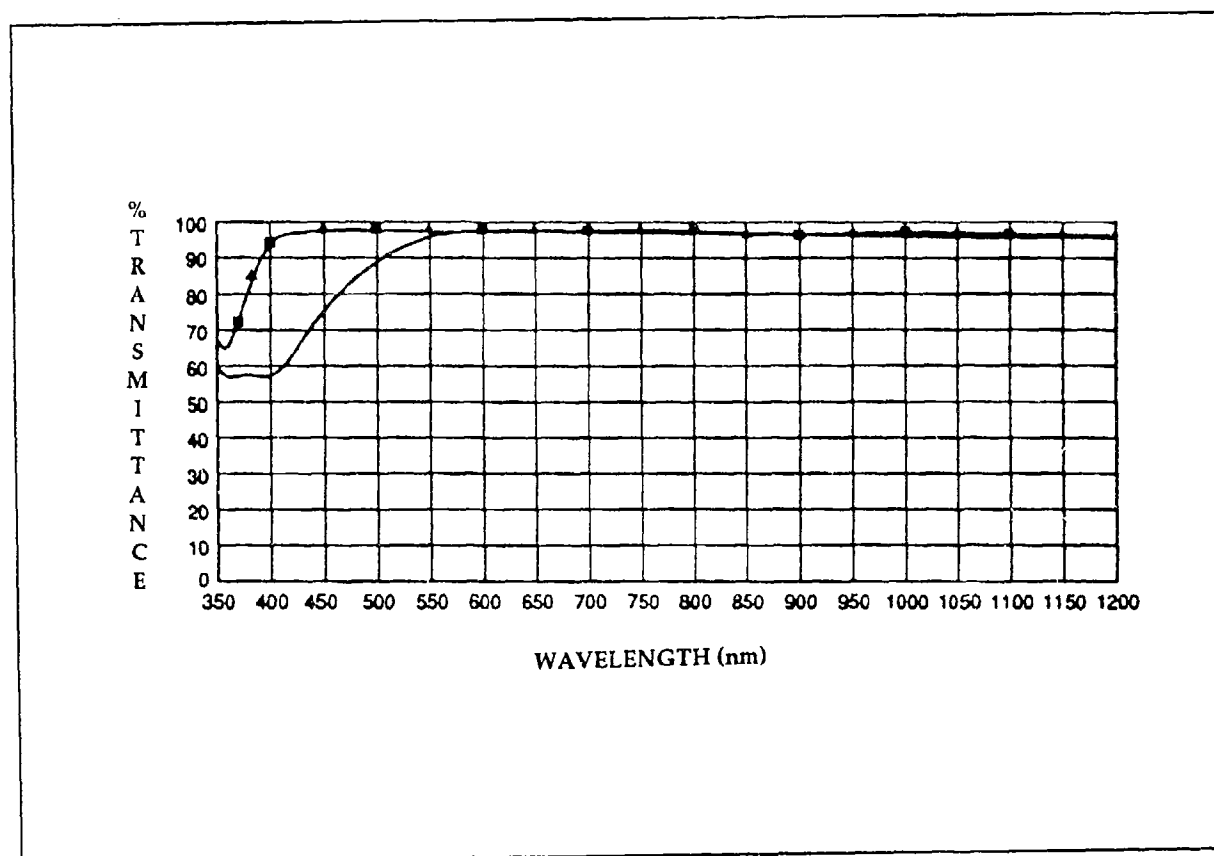
Figure E.31. Reflectance for Silver-Coated ULE™

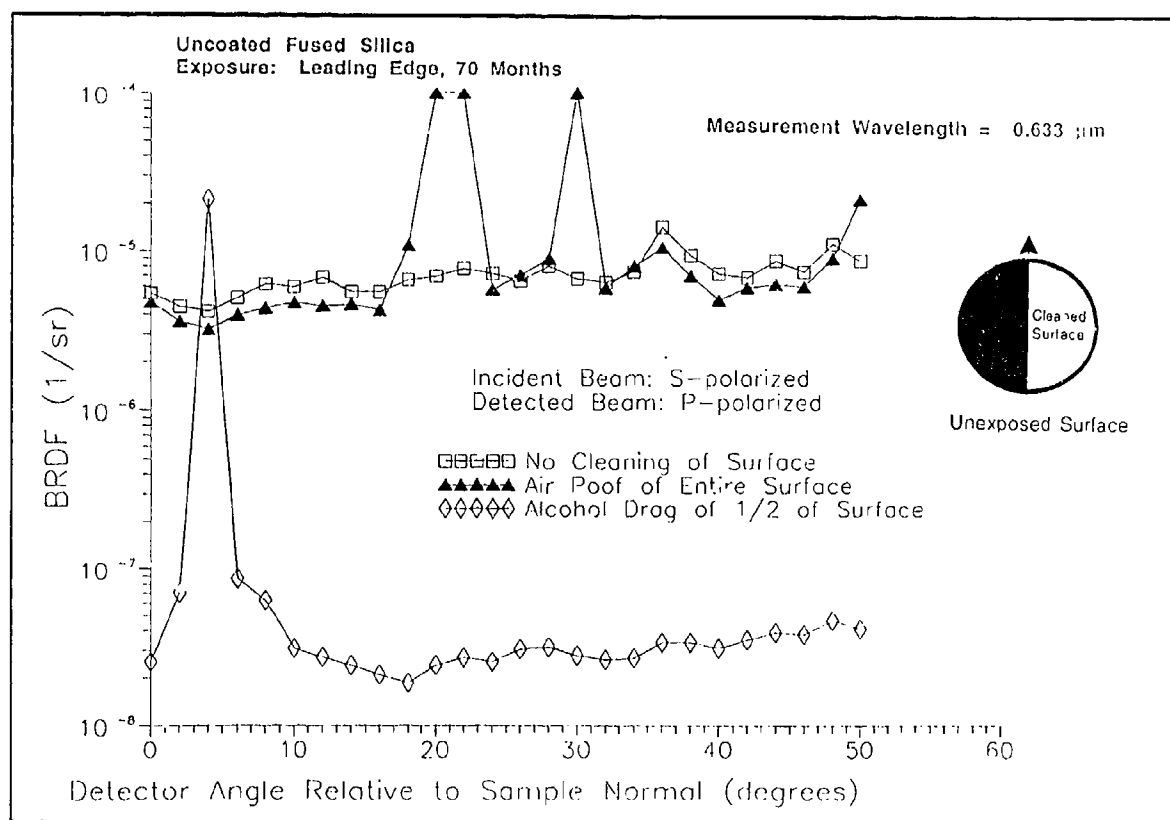
Figure E.39. Effects of Cleaning on Fused Silica Scatter

<b>REFERENCE:</b>	DeHainaut, Linda L., Kenemuth, John R., Tidler, Cynthia E., and Seegmiller, David W., <u>Degradation of Optical Components in a Space Environment</u> , LDEF Second Post-Retrieval Symposium, June 1992, p. 1372
<b>EXPERIMENT:</b>	M0003-2
<b>COMMENTS:</b>	70-month exposure. Cleaning reduced scatter three orders of magnitude.

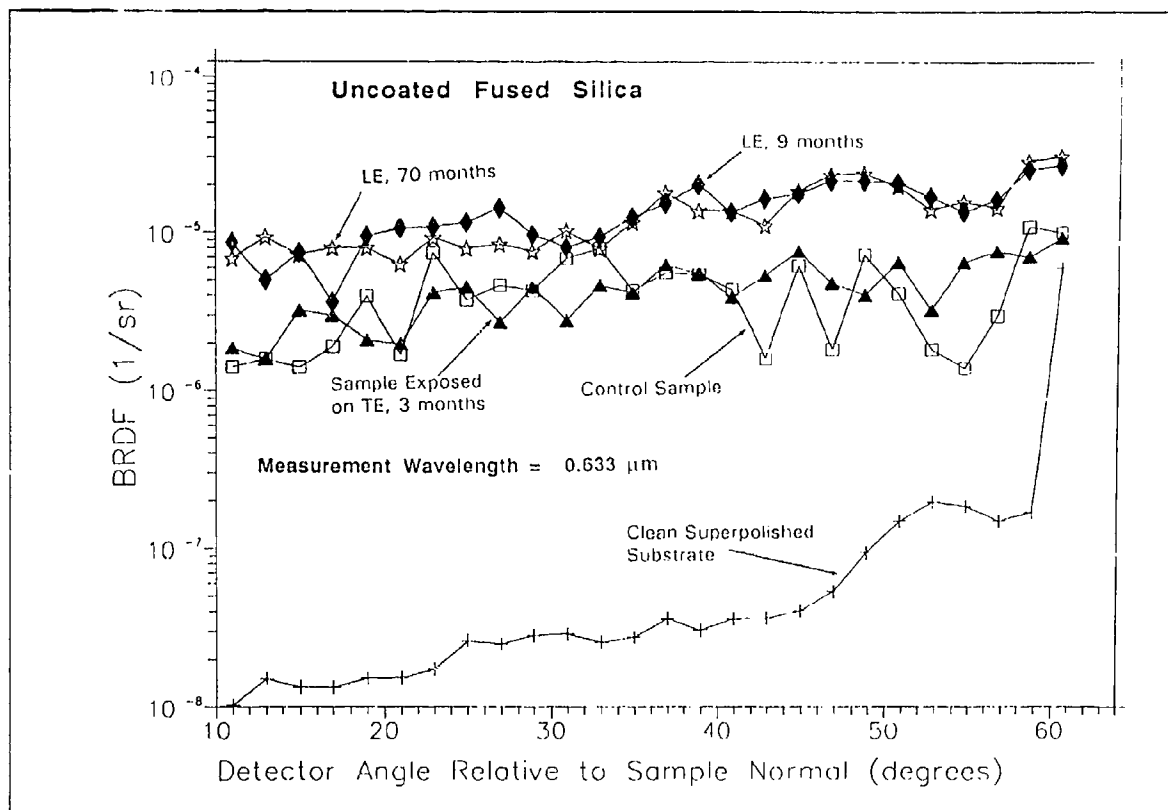
Figure E.40. Exposure Effects on Fused Silica Scatter

<b>REFERENCE:</b>	DeHainaut, Linda L., Kenemuth, John R., Tidler, Cynthia E., and Seegmiller, David W., <u>Degradation of Optical Components in a Space Environment</u> , LDEF Second Post-Retrieval Symposium, June 1992, p. 1372
<b>EXPERIMENT:</b>	M0003-2
<b>COMMENTS:</b>	Leading edge 70-month exposure similar to 9-month exposure.

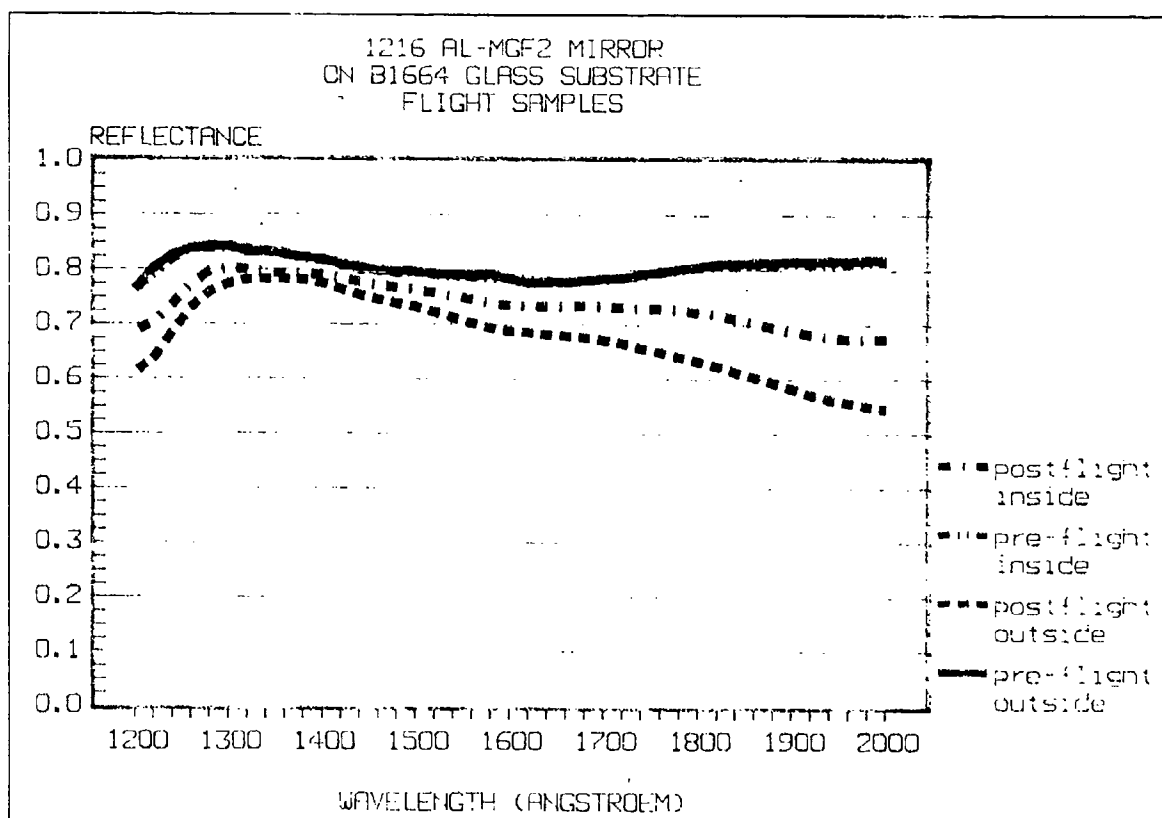
Figure E.41. Reflectance Measurements for Al-Mg<sub>2</sub>/B1664 Glass Mirror

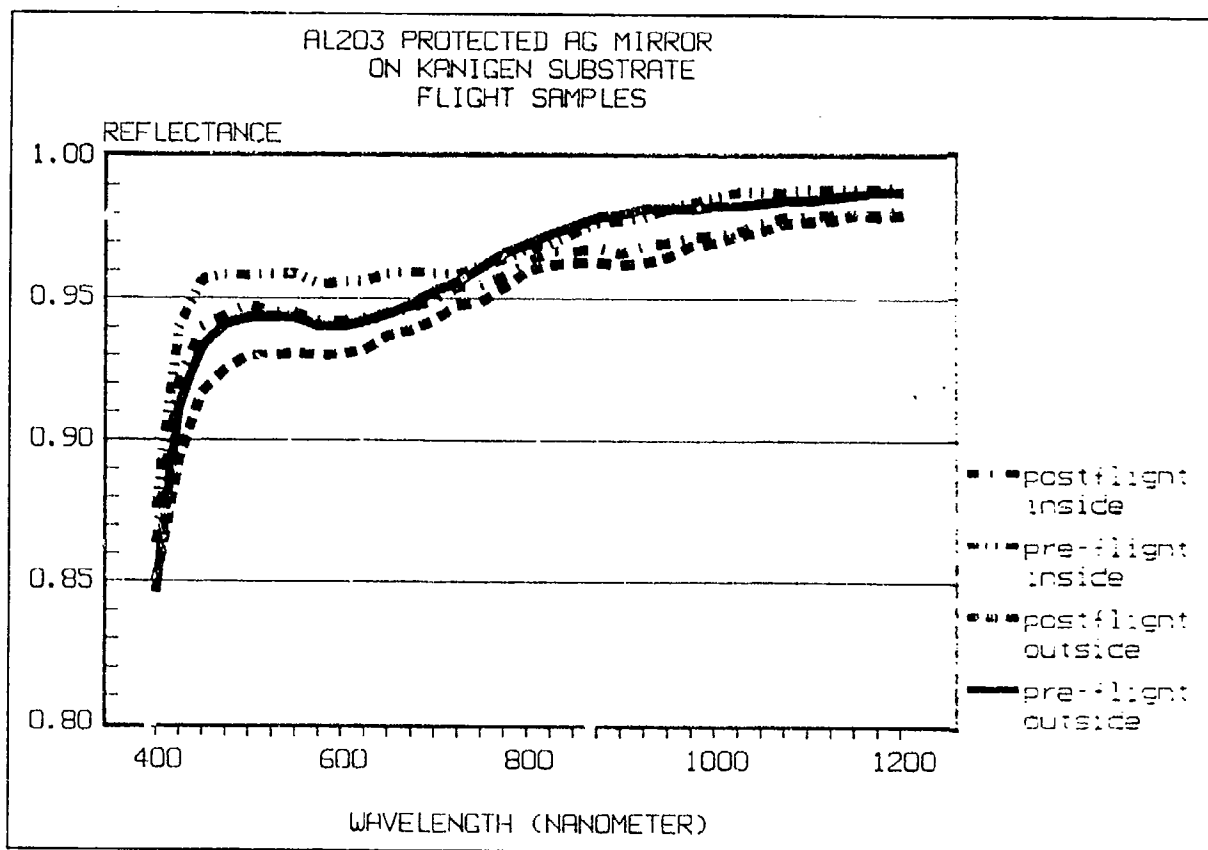
Figure E.43. Reflectance Measurements For  $\text{Al}_2\text{O}_3$ -Ag/Kanigen Mirror

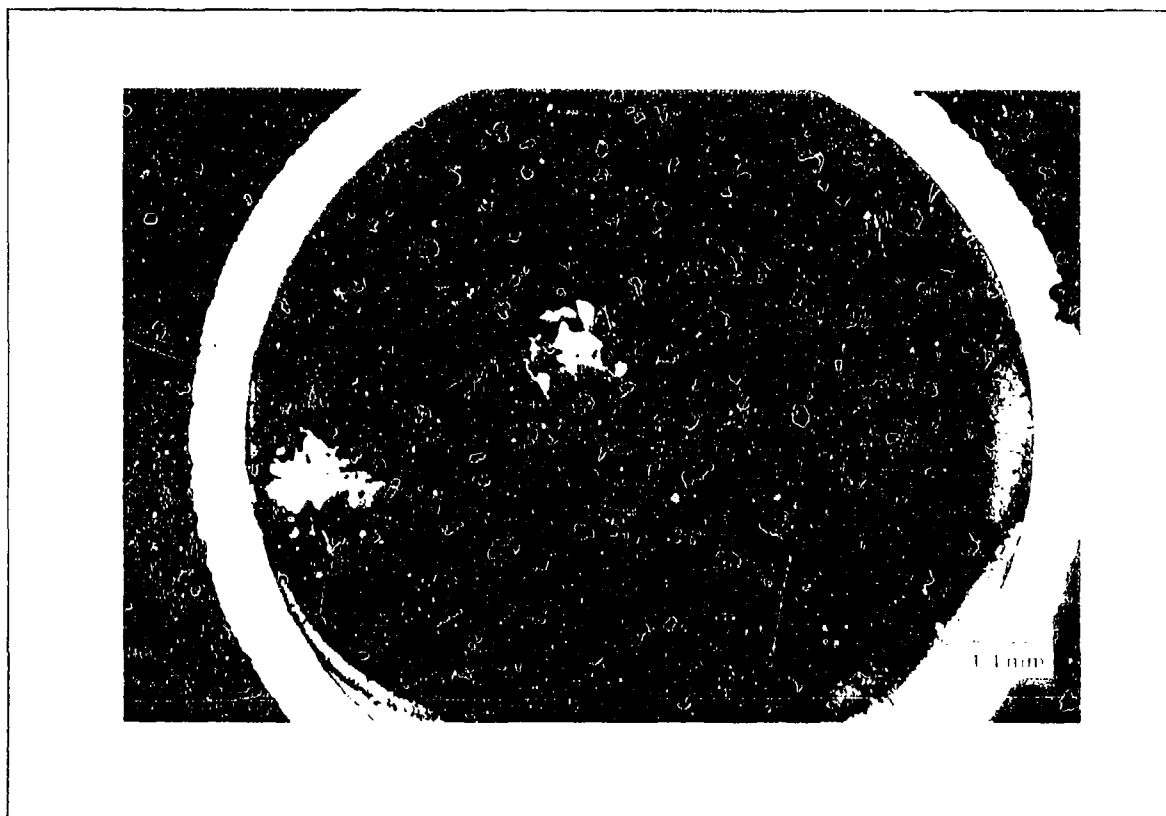
Figure E.48.  $\text{NaF}_2$  Coating on Fused Silica

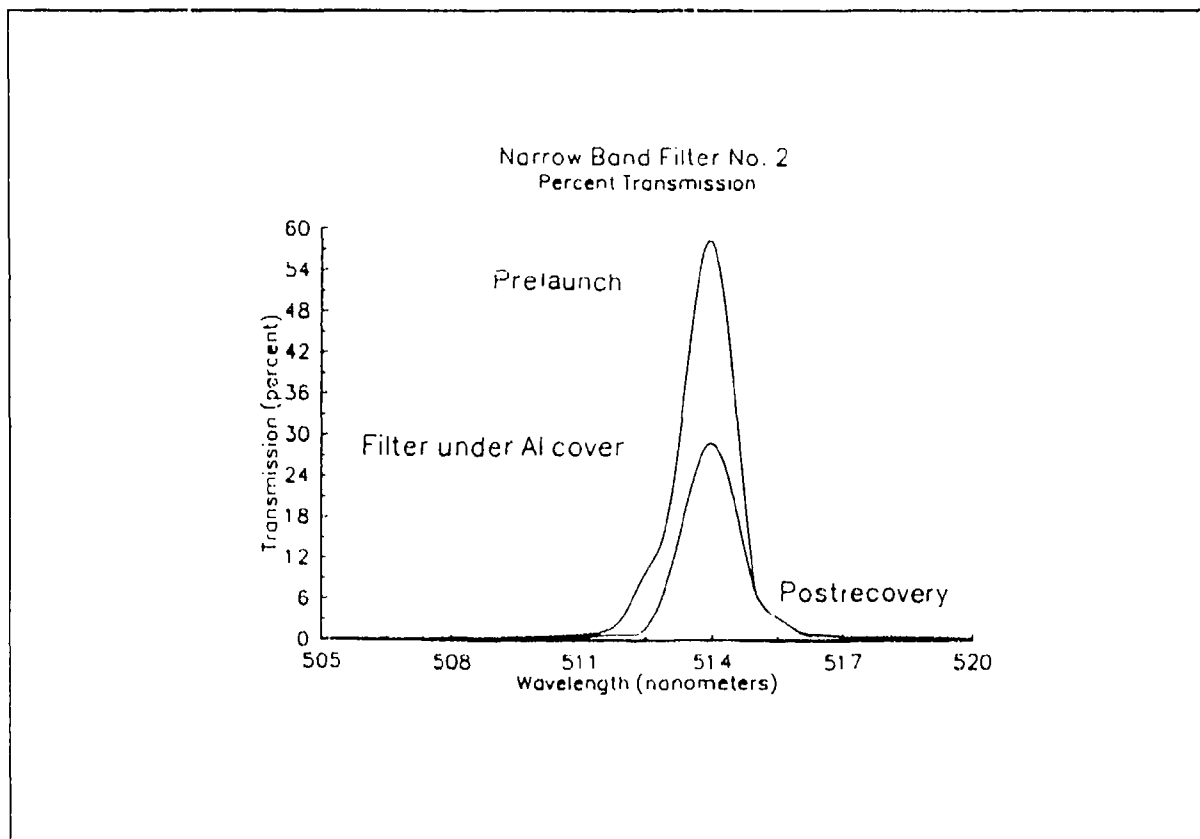
Figure E.62. Pre-Launch and Post-Recovery Transmission of Corion Narrow-Band Filter #2 (Covered)

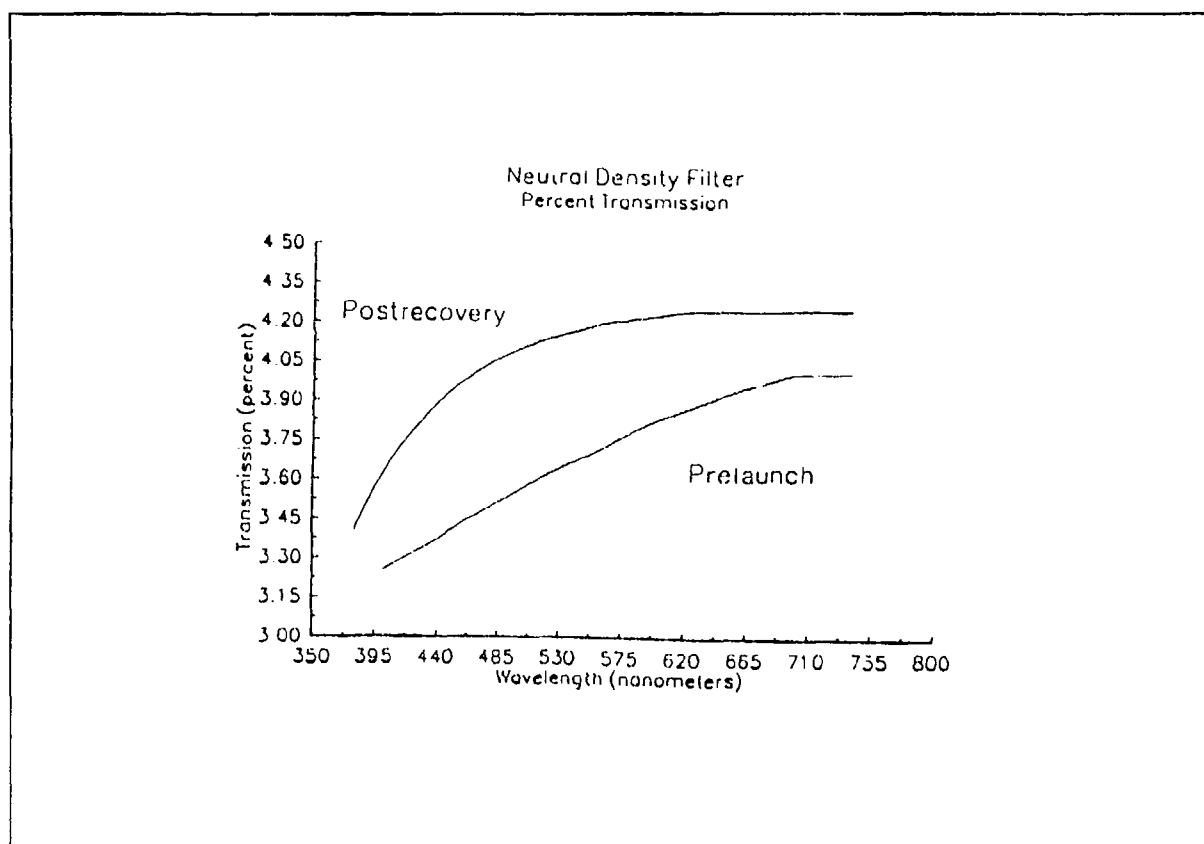
Figure E.72. Pre-Launch and Post-Recovery Transmission of Exposed Corion Neutral Density Filter #6

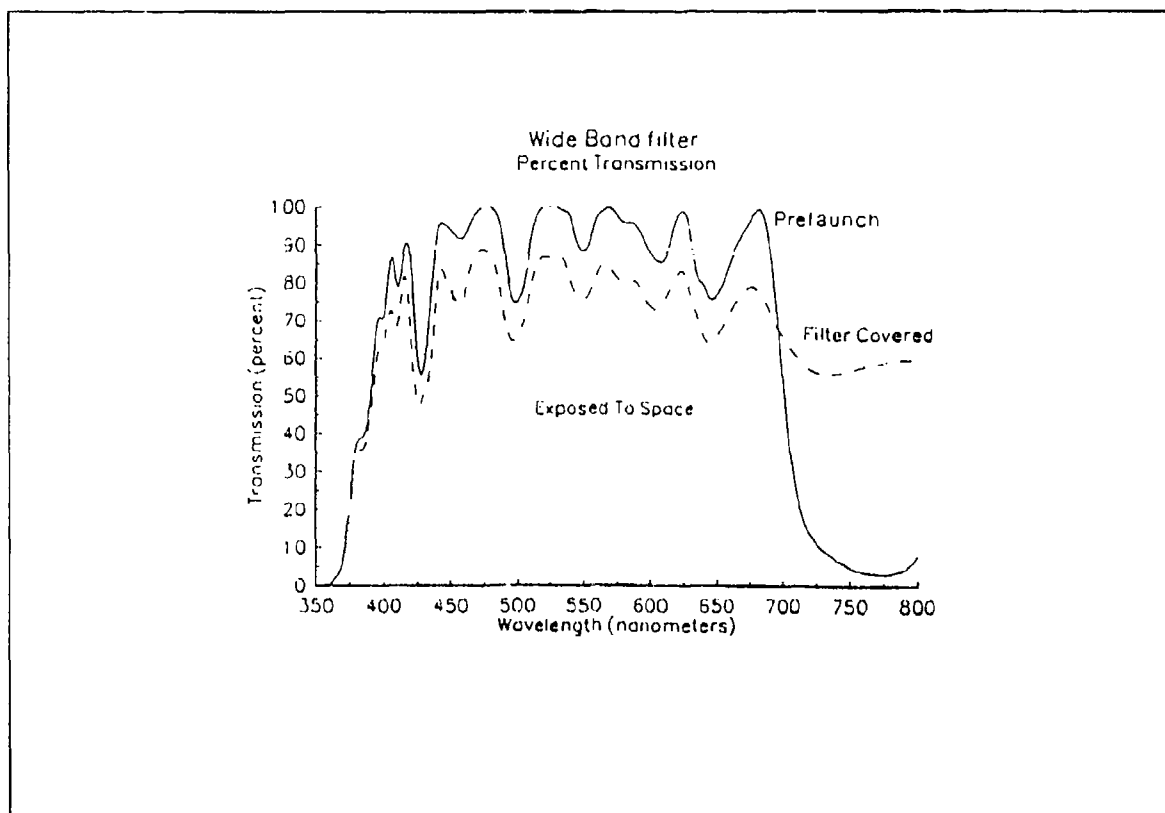
Figure E.73. Pre-Launch and Post-Recovery Transmission of Wide-Band Corion Filters #8 (Exposed) and #9 (Covered)

<b>REFERENCE:</b>	M.D. Blue, GTRI, Investigation of the Effects of LDEF on Active Optical System Components, Final Report
<b>EXPERIMENT:</b>	S0050-2
<b>COMMENTS:</b>	No shift in filter wavelength characteristics. Transmission and long-wave reflectance degraded.

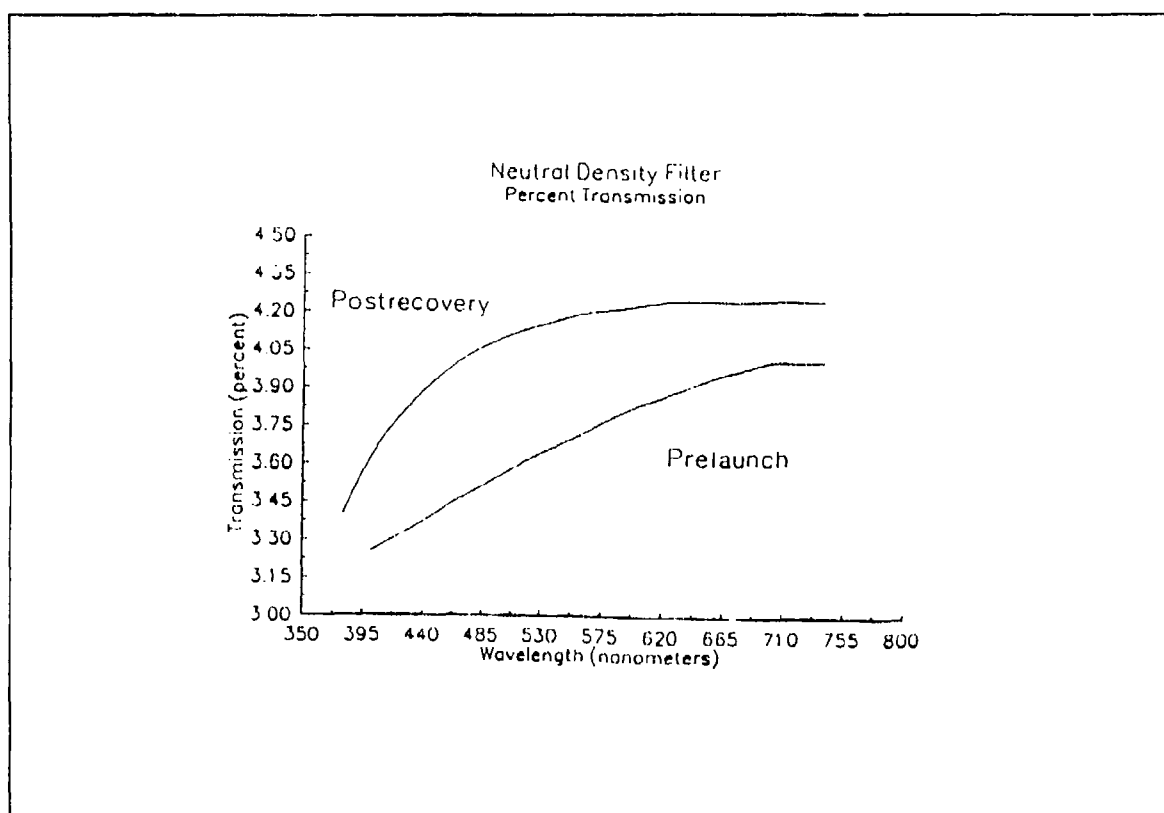
Figure E.72. Pre-Launch and Post-Recovery Transmission of Exposed Corion Neutral Density Filter #6

REFERENCE:	M.D. Blue, GTRI, Investigation of the Effects of LDEF on Active Optical System Components, Final Report
EXPERIMENT:	S0050-2
COMMENTS:	Increase in transmittance.

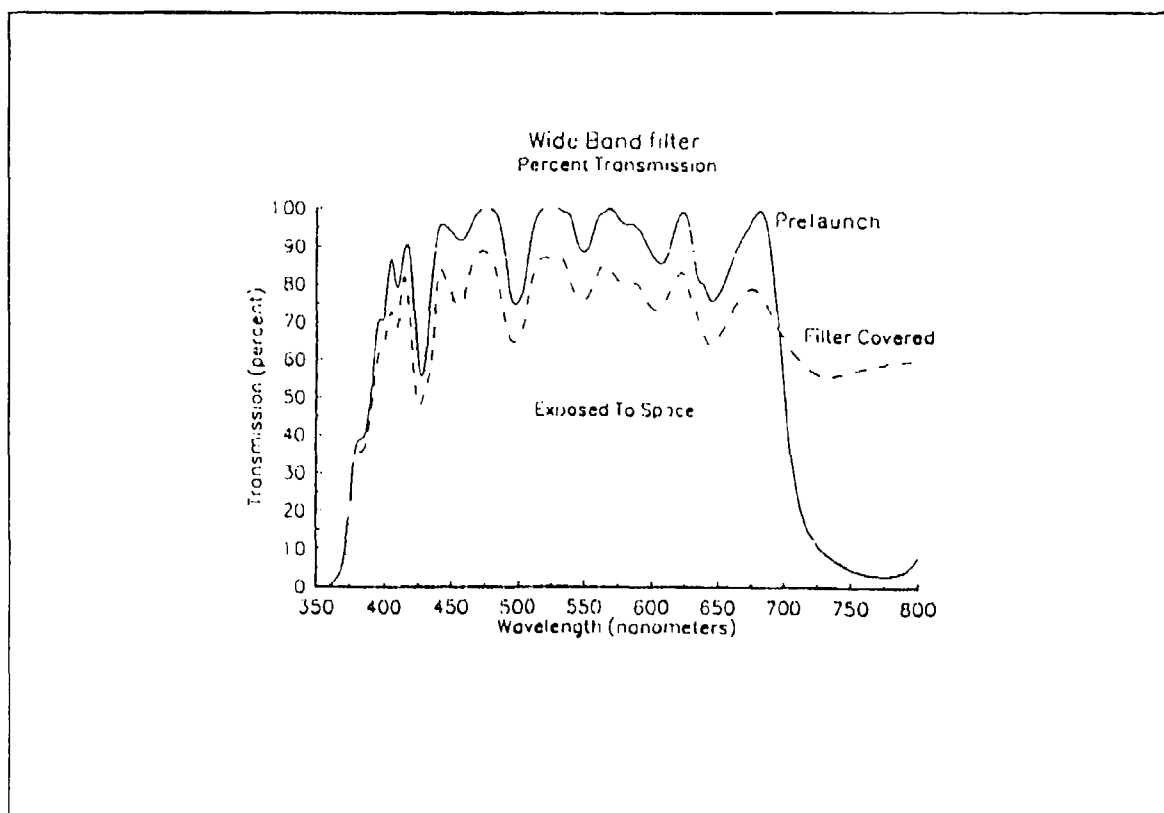
Figure E.73. Pre-Launch and Post-Recovery Transmission of Wide-Band Corion Filters #8 (Exposed) and #9 (Covered)

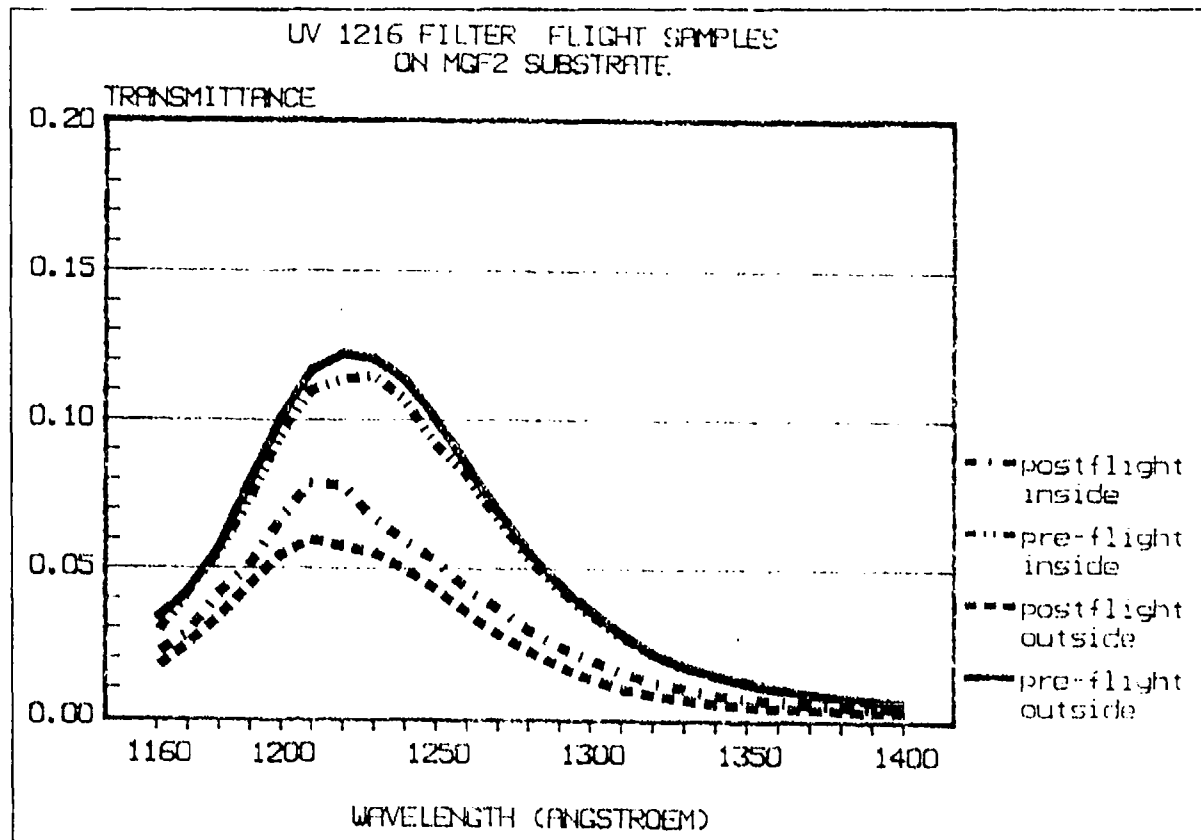
Figure E.74. Pre-Launch and Post-Recovery Transmission of Exposed Al/MgF<sub>2</sub> Optical Filter on MgF<sub>2</sub> Substrate (1216 Å)

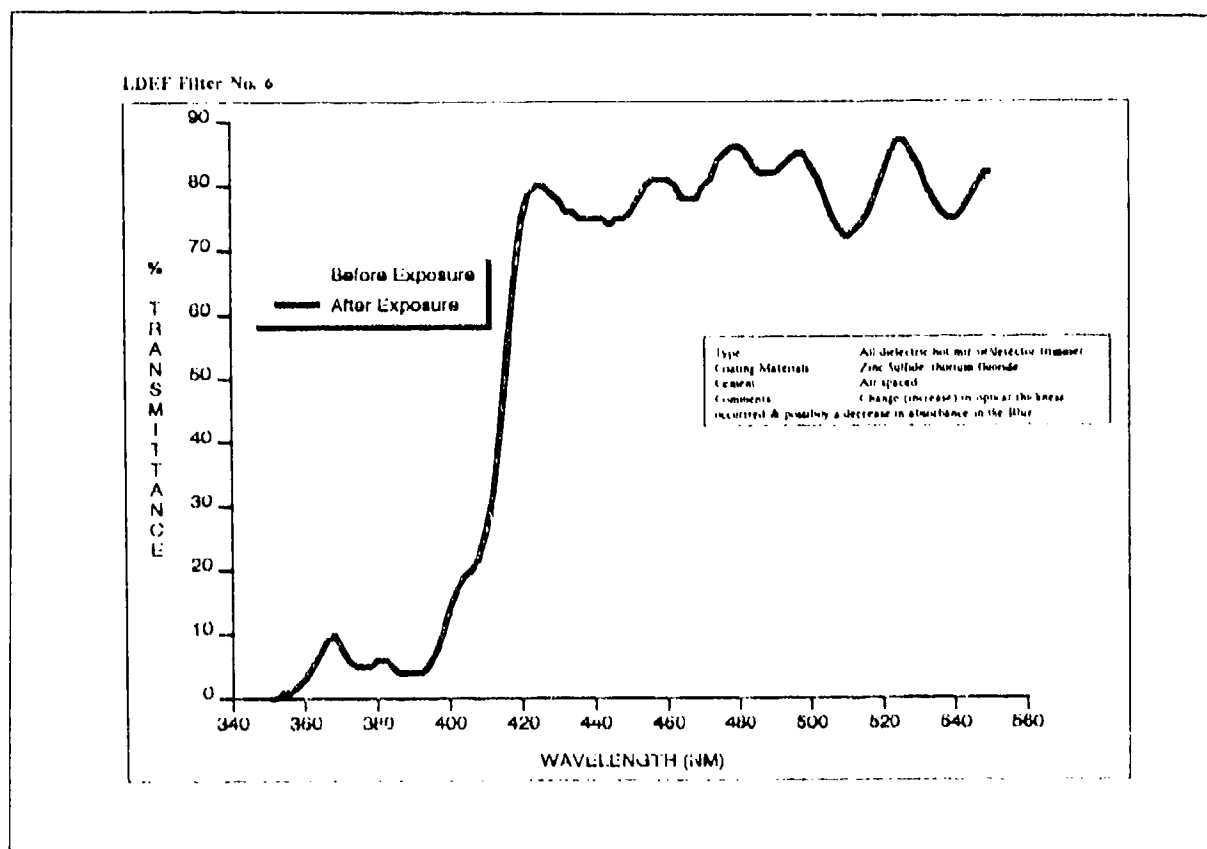
Figure E.81. Pre-Launch and Post-Recovery Transmission of ZnS/TiF<sub>4</sub> on Fused Silica (Air-Spaced, No Cement)

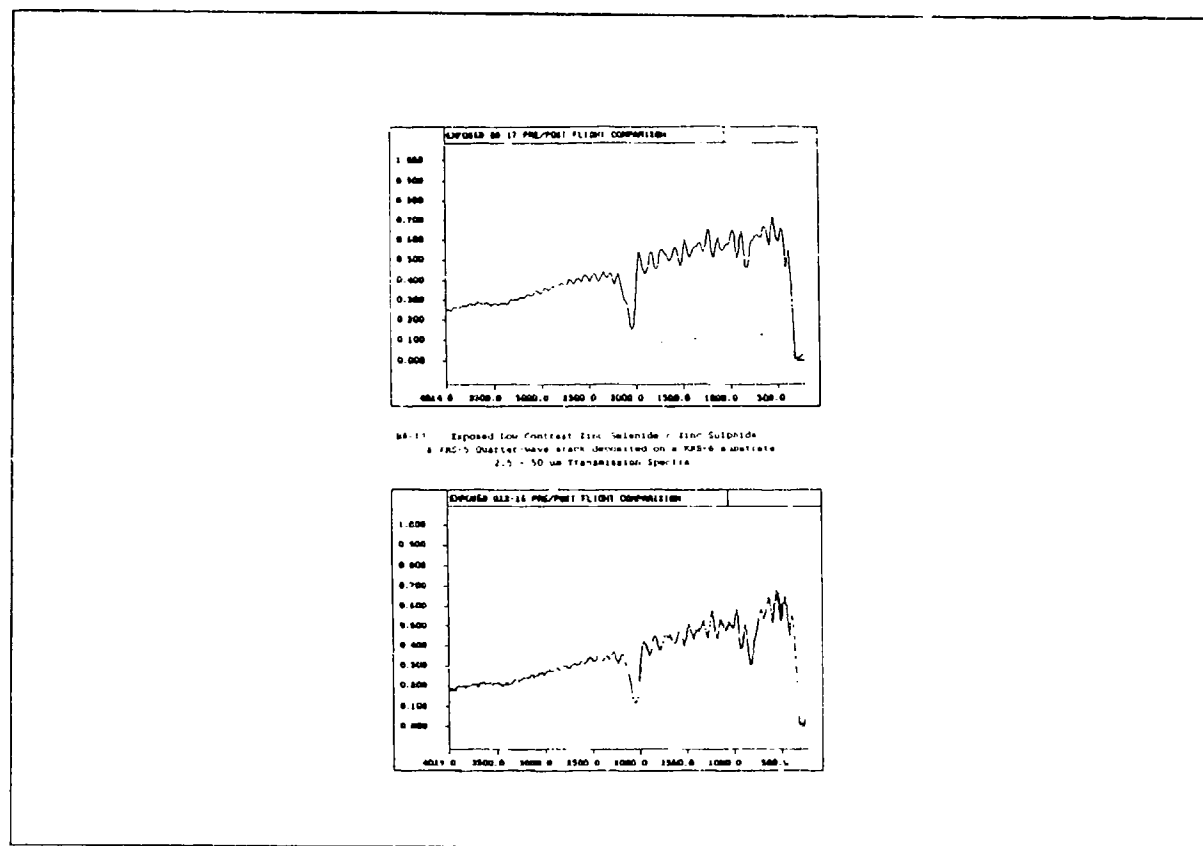
Figure E.86. Pre-Launch and Post-Recovery Transmission of Low Index Ratio Quarter-Wave Blocking ZnSe/ZnS/KRS-5 on KRS-6 Substrate

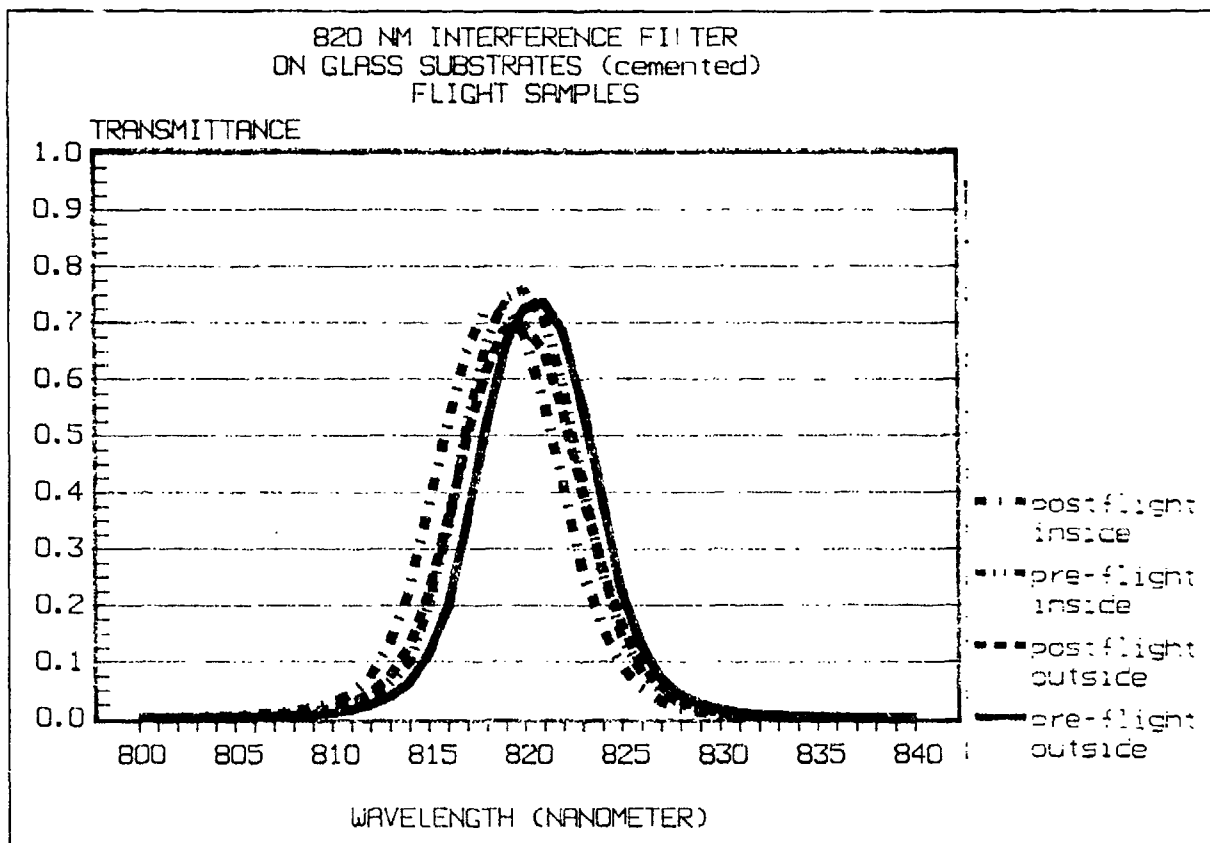
Figure E.90. Pre-Launch and Post-Recovery Transmission of ZnS/Chiolite on BK7G18 and RG780 Glasses (820 nm Interference Filter)

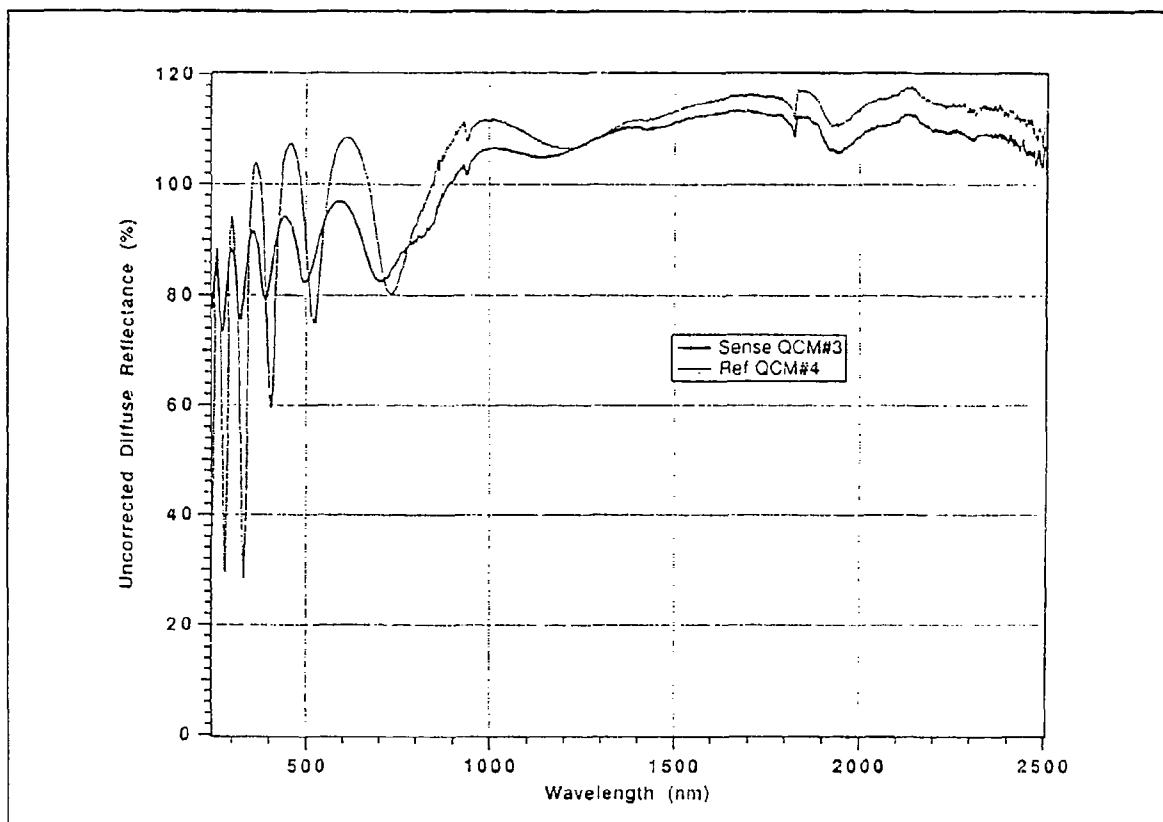
**Figure E.97. Diffuse Reflectance Spectra of  $\text{In}_2\text{O}_3/\text{Al}/\text{Al}_2\text{O}_3$  Coated Quartz Crystal Microbalance, LDEF Leading Edge**

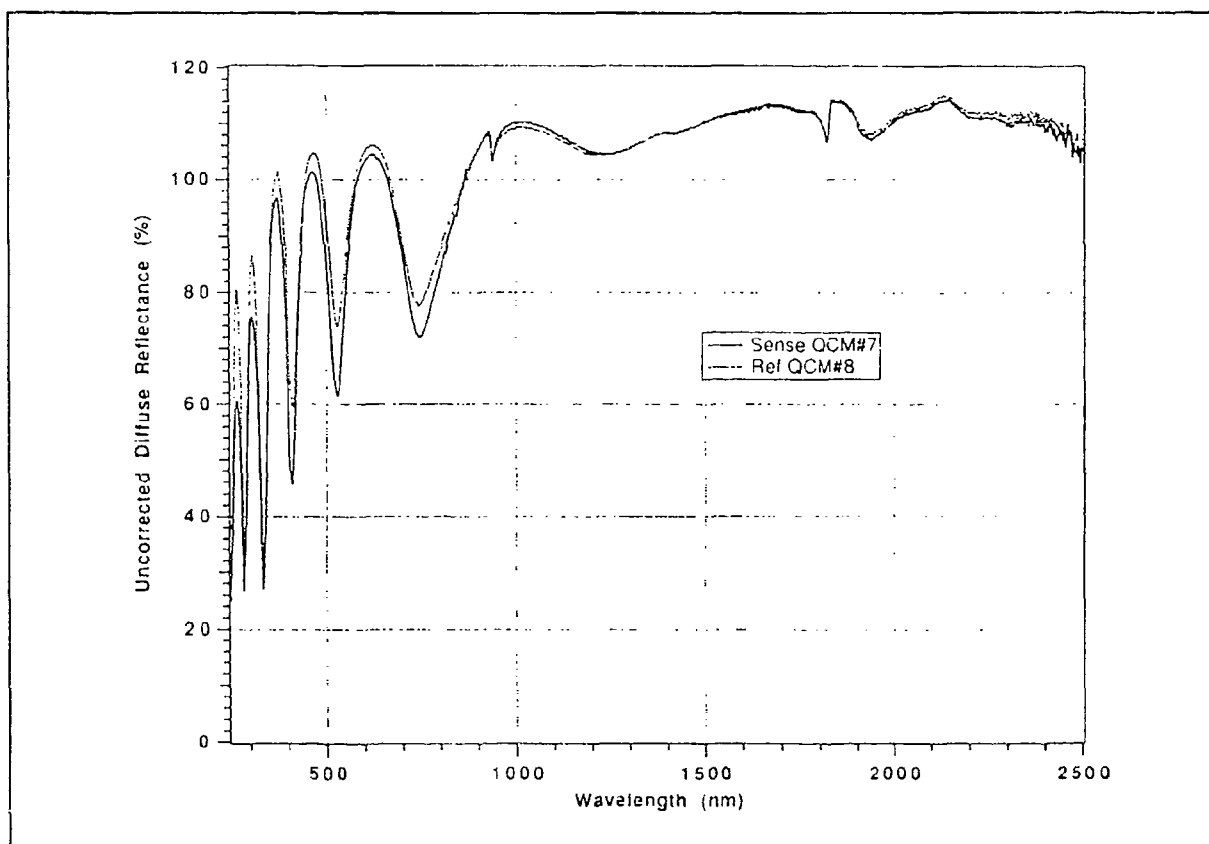
**Figure E.100. Diffuse Reflectance Spectra of ZnS/Al/Al<sub>2</sub>O<sub>3</sub> Coated Quartz Crystal Microbalance, LDEF Trailing Edge**

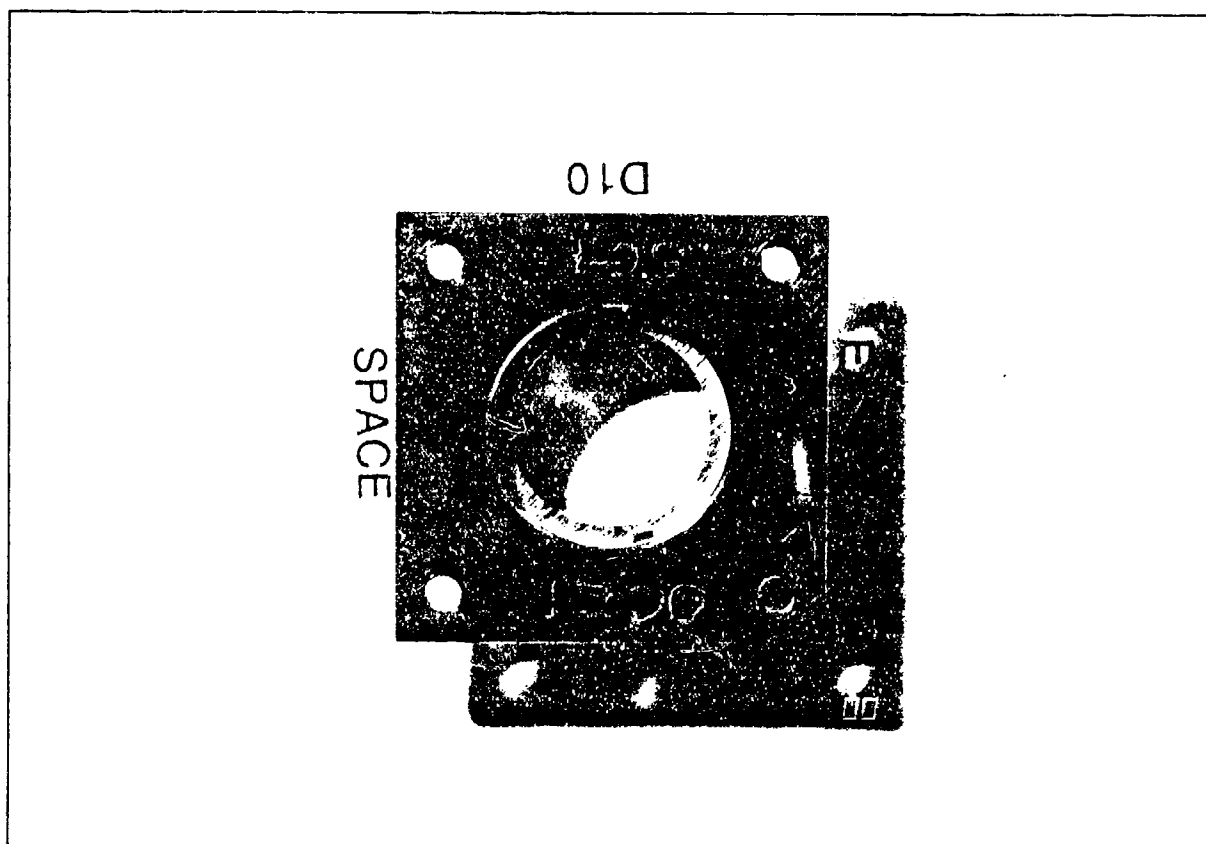
Figure E.101. Microfractured and Contaminated Mark III Coating on 7940 Coverglass

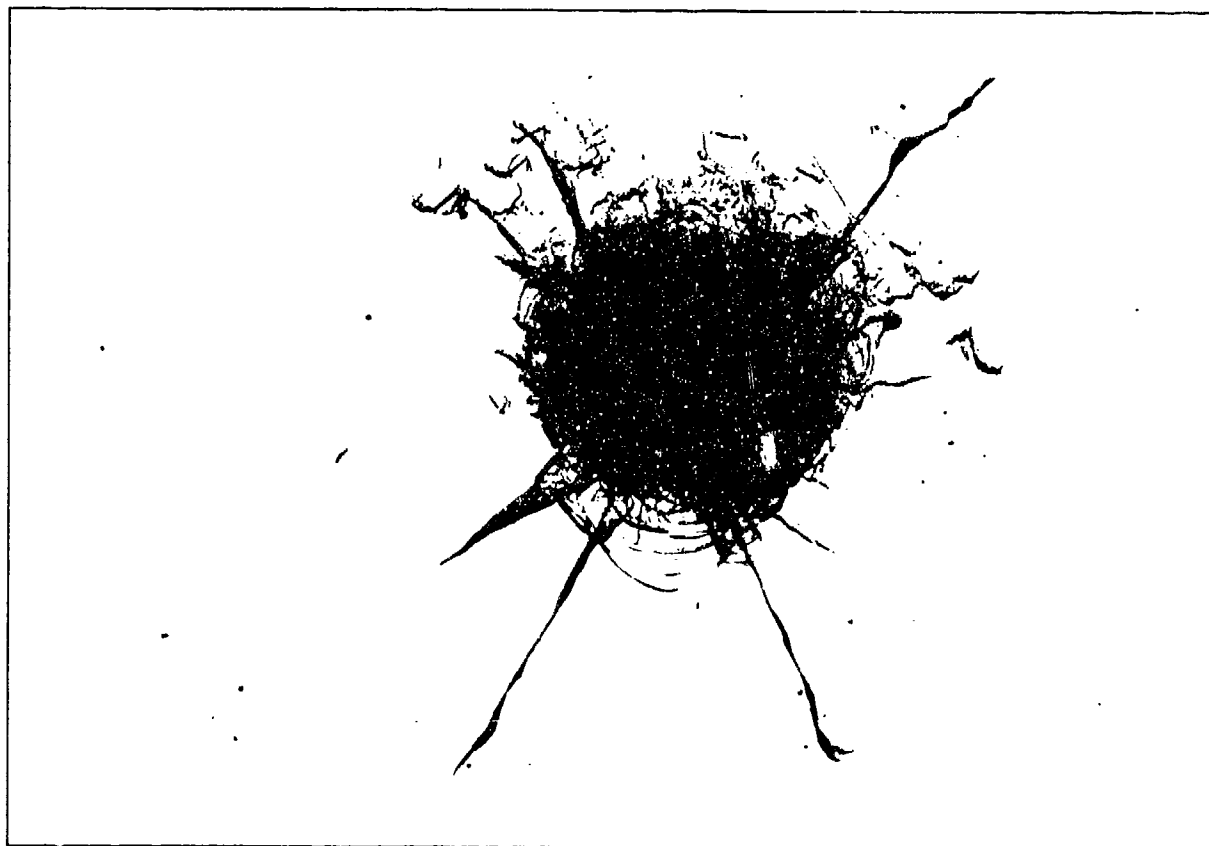
**Figure E.103. Impact Crater, 1.25 mm Diameter, in Surface of Bare 7940 Coverglass**

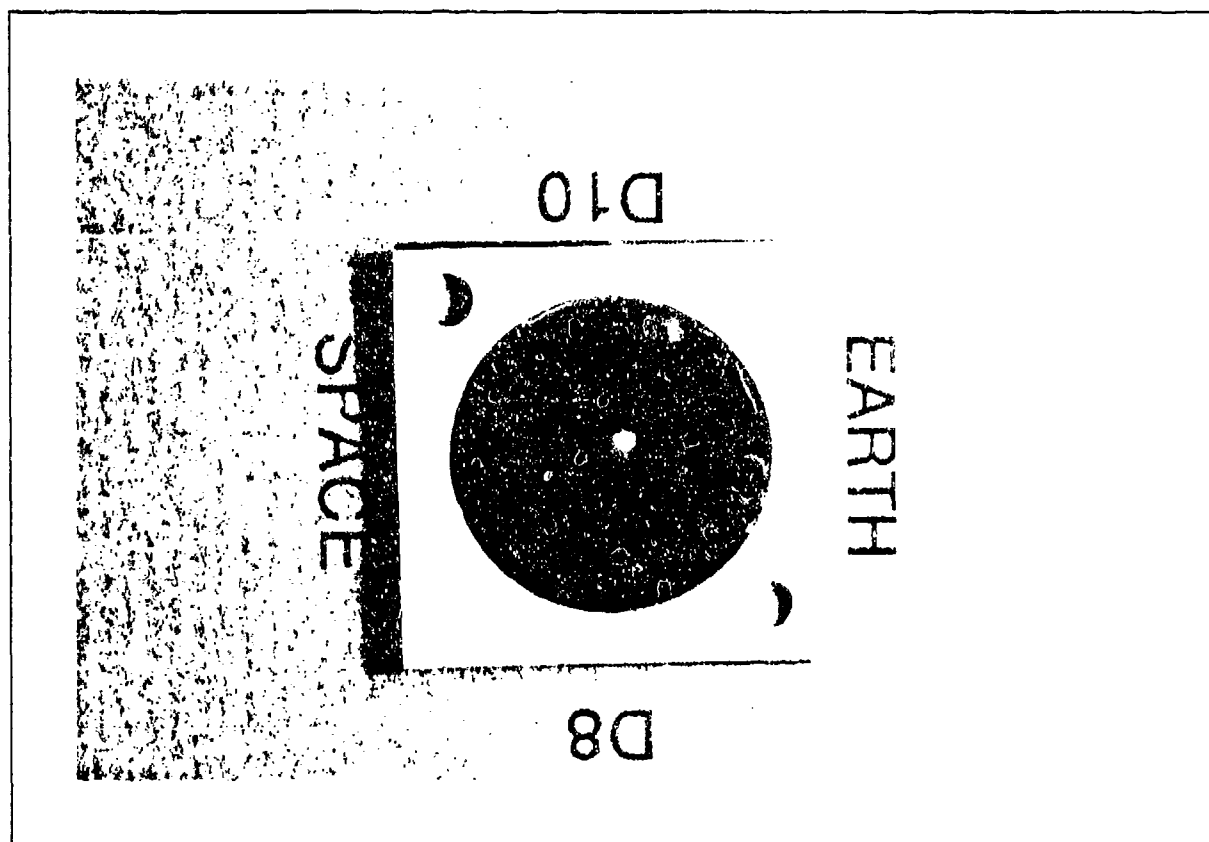
**Figure E.104. Macrophotograph of Hazed and Contaminated 7940 Coverglass with 1.25 mm Diameter Crater Off-Center in Surface**

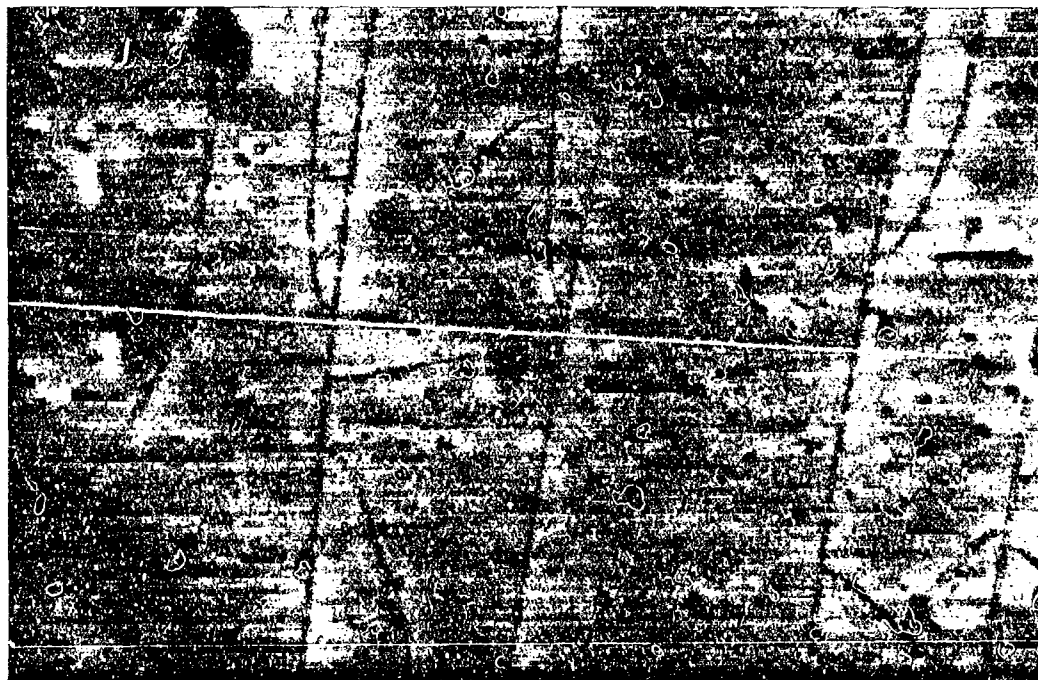
Figure E.106. Microcracked Mark IIID Coating on 7940 Coverglass
